Infrared Thermographic Survey of Nominated Electrical Equipment

Sample Report P/L 3/42 Burgess Road, Bayswater Vic 3153

Inspection Date	Wednesday, October 26, 2016
Address	3/42 Burgess Road, Bayswater Vic 3153
Contact person	The Manager
Phone number	03 9832 0806
E-mail address	sample@neservices.com.au
Thermographer	Dave Lambert
Electrician/s	Dave Lambert
Test Equipment Used	Flir, T420, Thermal Imaging Camera
Prothermal Reference

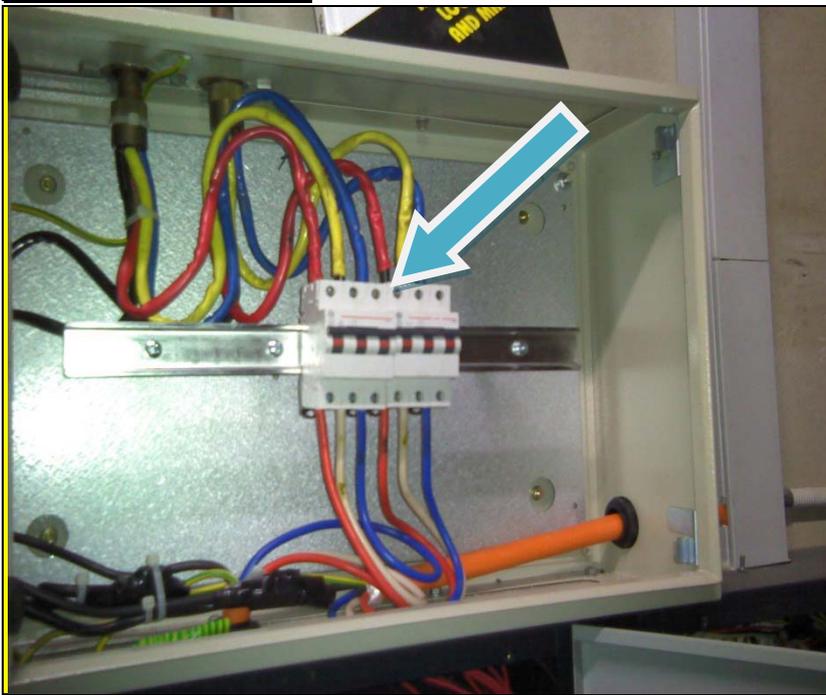
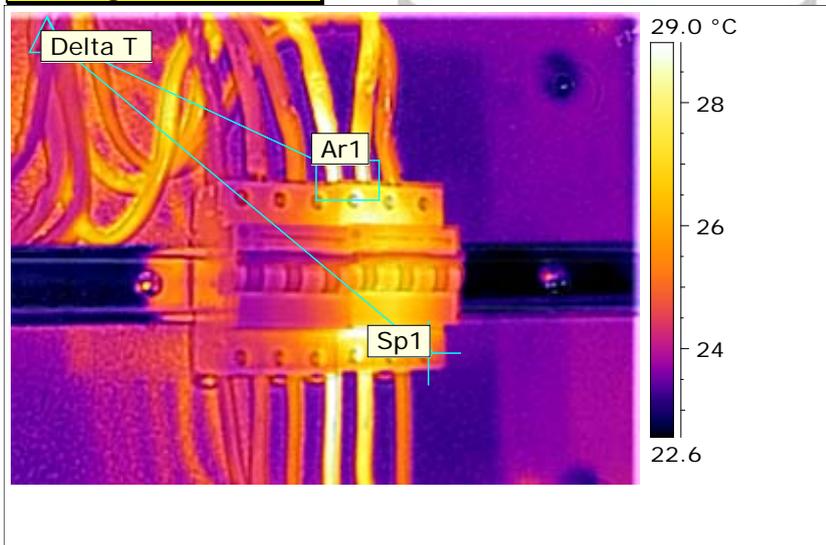
Distribution Board , L1A

Medium, loose connection at red phase of circuit breaker 2.

Ar1 Max. Temperature	29.9 °C
Sp1 Temperature	25.3 °C
Delta T Value	4.6 °C

Loose connection , recommend to shut down inspect and rectify.

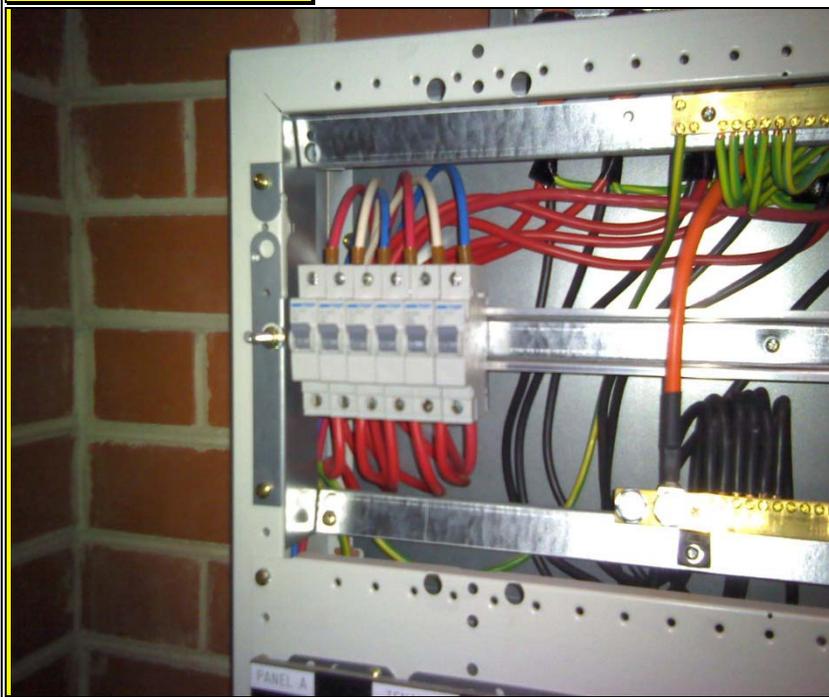
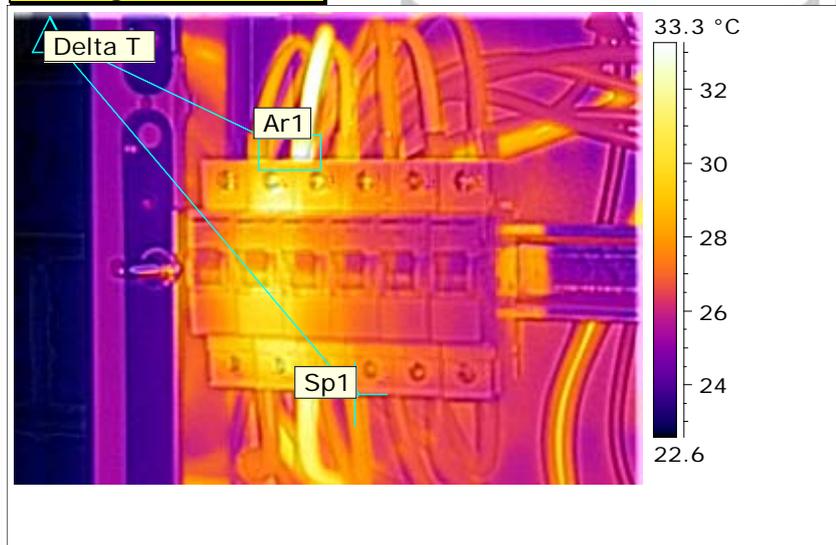
Equipment Description :- 3rd Floor, Main Isolator Panel

Priority Description :- **Rectified**, Loose connection was tightened at time of inspection.

Ar1 Max. Temperature	34.2 °C
Sp1 Temperature	27.1 °C
Delta T Value	7.0 °C

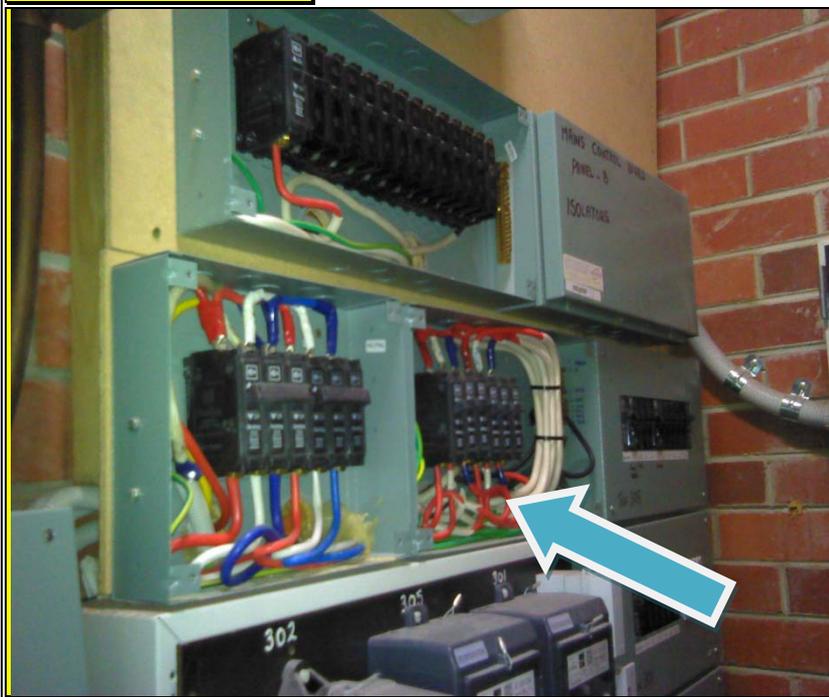
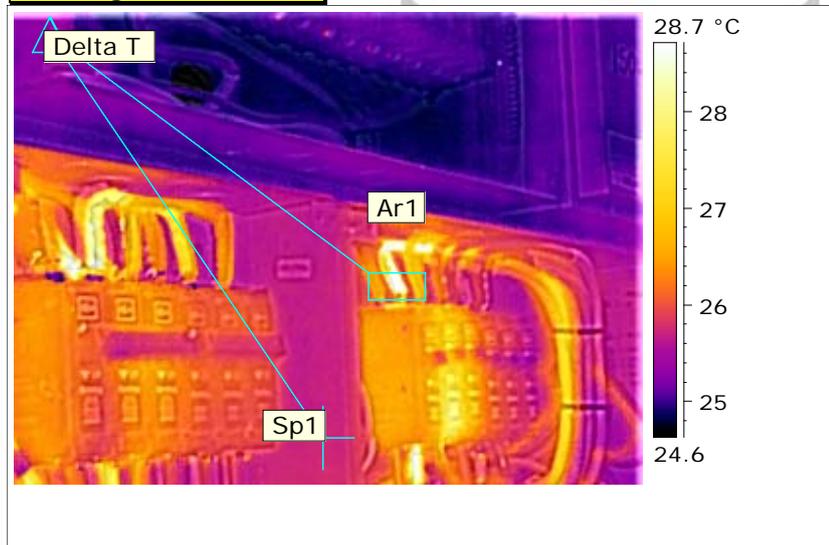
4th Level, Public Area Switchboard

Non Thermal, board requires fire stop sealant around cables

Ar1 Max. Temperature	30.7 °C
Sp1 Temperature	25.7 °C
Delta T Value	4.9 °C

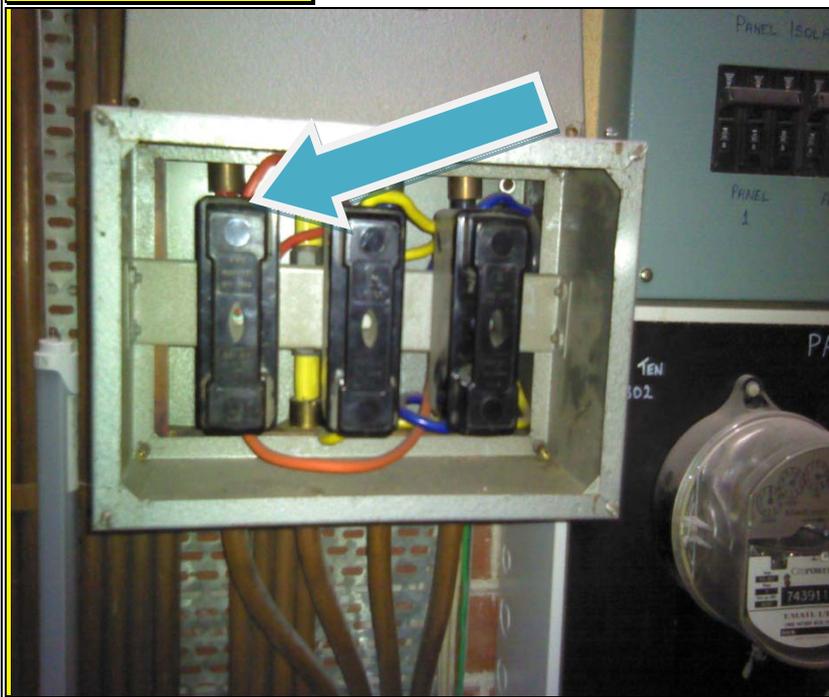
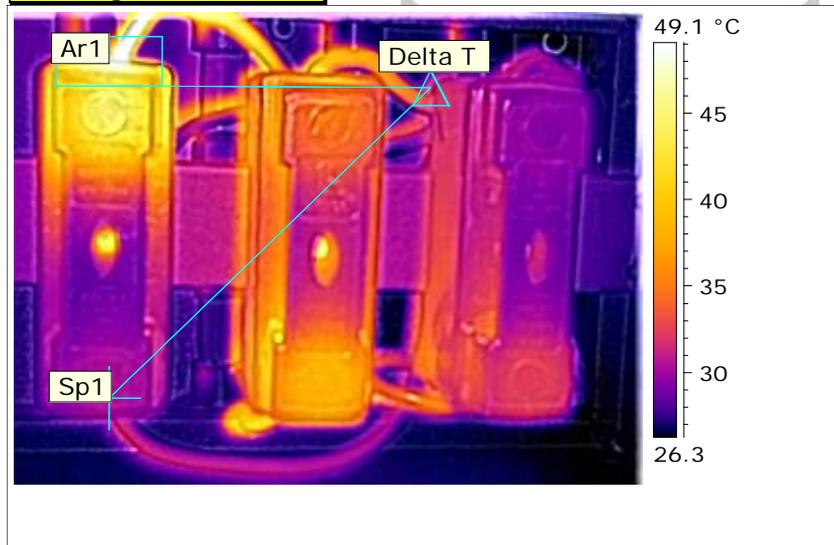
Level 7, Take off box fuses.

High, Contact electrician and rectify

Ar1 Max. Temperature	56.9 °C
Sp1 Temperature	30.4 °C
Delta T Value	26.5 °C

Localized heat source shown at top of fuse, shut down and inspect further.

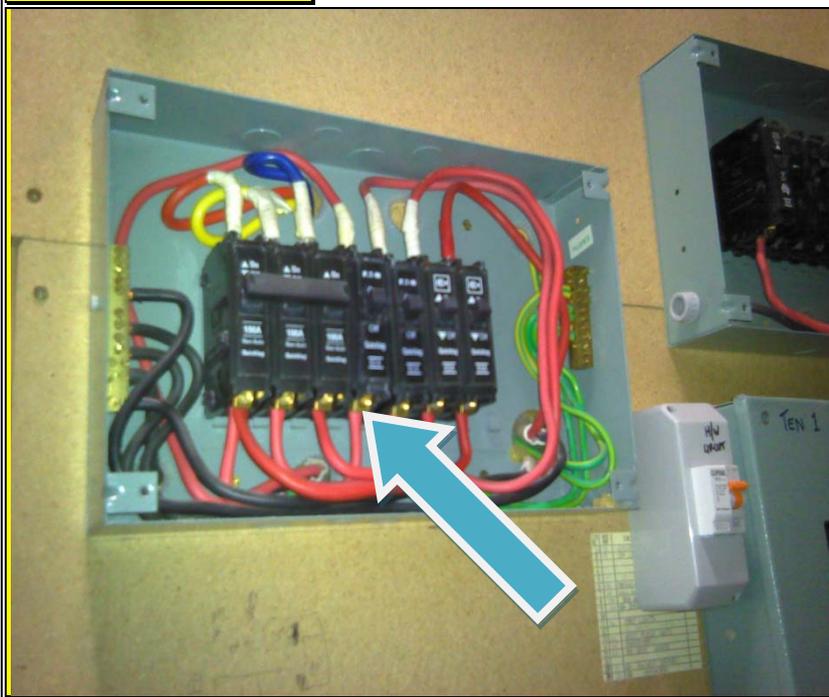
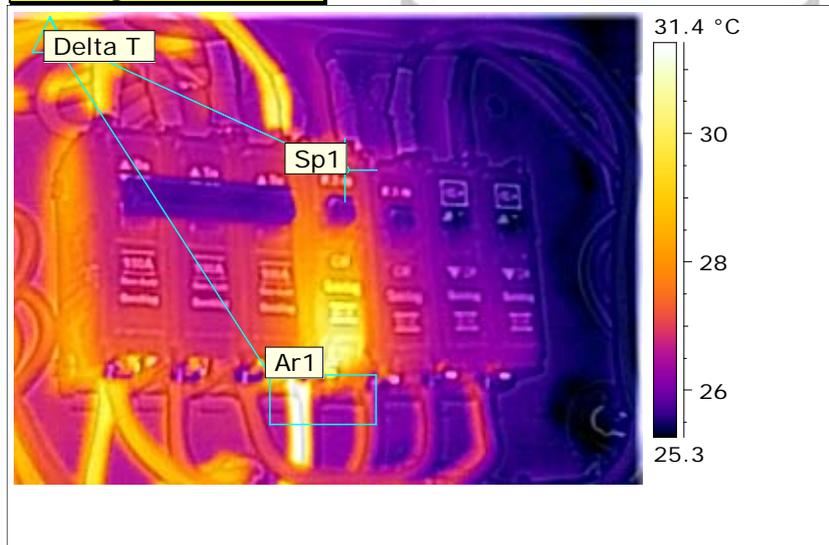
Level 8, Public Light and power

Medium, Non Thermal

Ar1 Max. Temperature	32.2 °C
Sp1 Temperature	27.0 °C
Delta T Value	5.2 °C

Load side of breaker is showing heat source, tightness of connection was inspected, possible worn components.

Protective barriers are also required to be fitted to switchboard cover.
